# Manhole Inspection Summary

Manhole # S27S1\_006MH

Insp Date: **5/5/08 2:38 PM**

**Location** Address: **700 W. Patapsco Ave.**

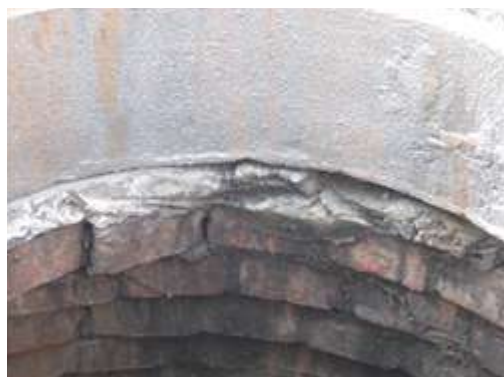
Defect 1

Infiltration: ☐ None ☐ Joint ☐ Cracks ☒ Mortar ☐ Roots ☐ Wall

Chimney

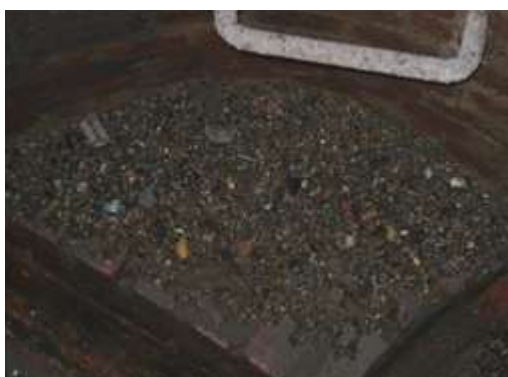
Defect 2

Slight debris

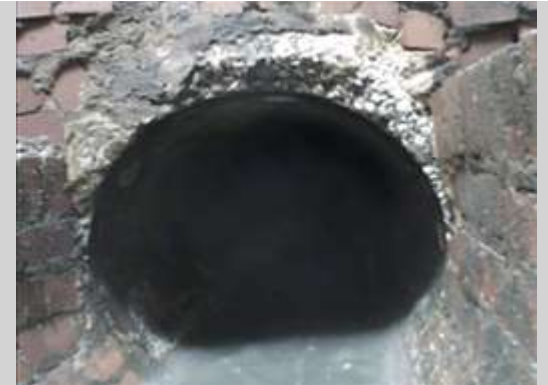
12 O'Clock Outflow

21 in. Circular Gravity Sewer  
Pipe Out @ 12 O'Clock

Pipe Height: **22.8** (in.) Rod and Bar (Angled)  
Pipe Material: **Concrete** ☐ Pipe Lined  
Invert Depth: **8.06** (ft.) Flow Characteristics: **Fast**  
Deposits: ☒ None ☐ Mud ☐ Sludge ☐ Debris ☐ Grease  
Silt Depth: (in.) Deposits Extent:  
Infiltration: **None** Pipe Seal Cond: **Sound**

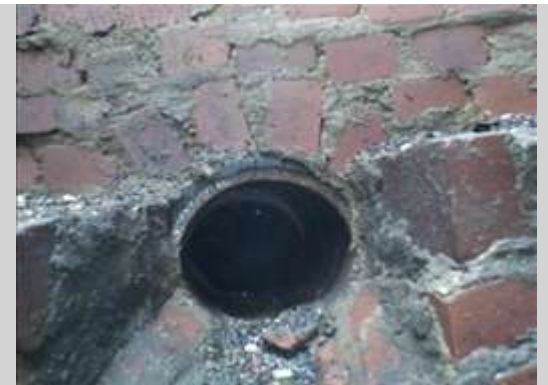
3 O'Clock Inflow

8 in. Circular Gravity Sewer  
Pipe In @ 3 O'Clock

Pipe Height: **8.4** (in.) Rod and Bar (Angled)  
Pipe Material: **Clay** ☐ Pipe Lined  
Invert Depth: **6.96** (ft.) Flow Characteristics: **None**  
Deposits: ☒ None ☐ Mud ☐ Sludge ☐ Debris ☐ Grease  
Silt Depth: (in.) Deposits Extent:  
Infiltration: **None** Pipe Seal Cond: **Sound**

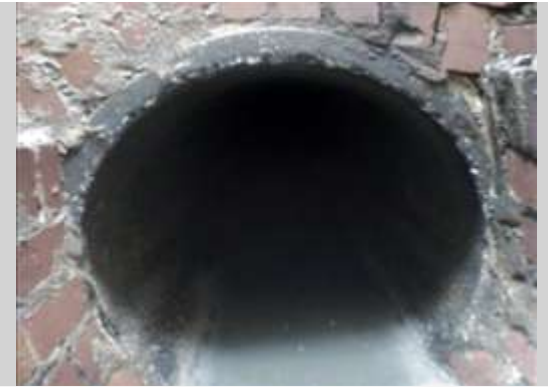
6 O'Clock Inflow

21 in. Circular Gravity Sewer

Pipe Height: **22.8** (in.) Rod and Bar (Angled)

Infiltration: **None** Pipe Seal Cond: **Sound**

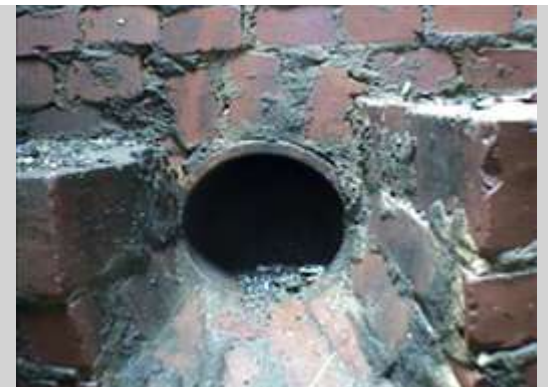
9 O'Clock Inflow

8 in. Circular Gravity Sewer

Pipe Height: **8.4** (in.) Rod and Bar (Angled)

Infiltration: **None** Pipe Seal Cond: **Sound**
